Case study
on the restoration
of the
1735 Richard Bridge Organ
at
Christ Church Spitalfields

The Organ Case

WILLIAM DRAKE Ltd
Organ Builder
Chapel Street, Buckfastleigh, Devon TQ11 0AB

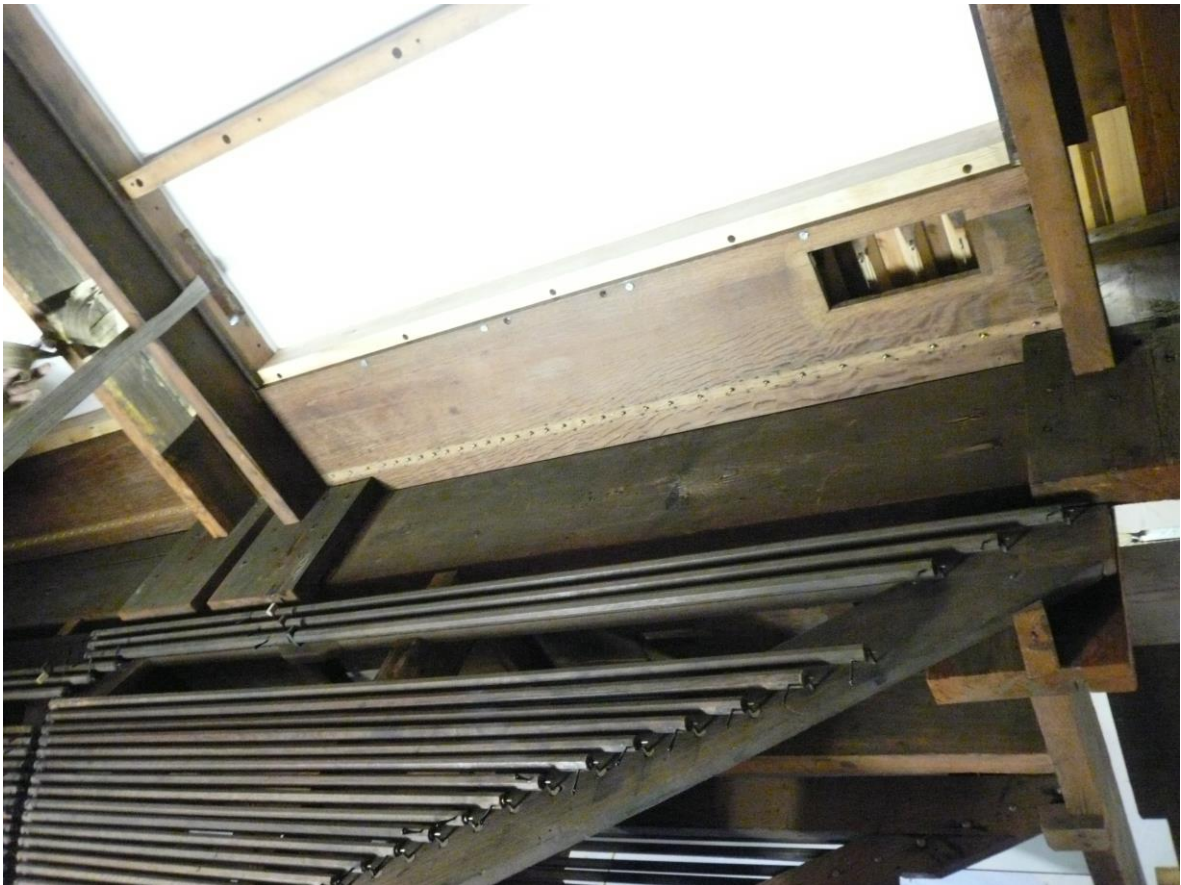
The reinstalled Great soundboards (note the dove tail brackets that are nailed onto the back rail of the impost)

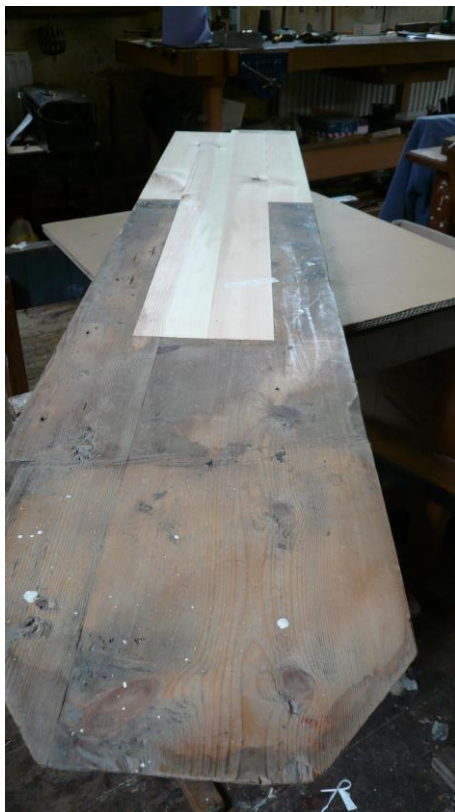
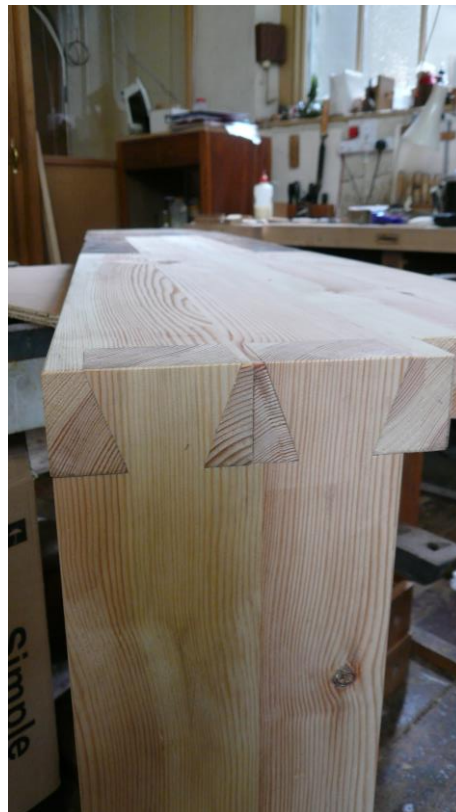
The cantilevers were found in a very much weakened state. They had been severely structurally compromised to fit large pedal pipes in the Great case.

On the bass side, the connection with the back of the case was completely missing, because it had been sawn in half to allow the insertion of DDD and DDD[#] of the Pedal Open Diapason.

Reconstructed Bass side cantilever fixed with dovetails into the new rear bracket

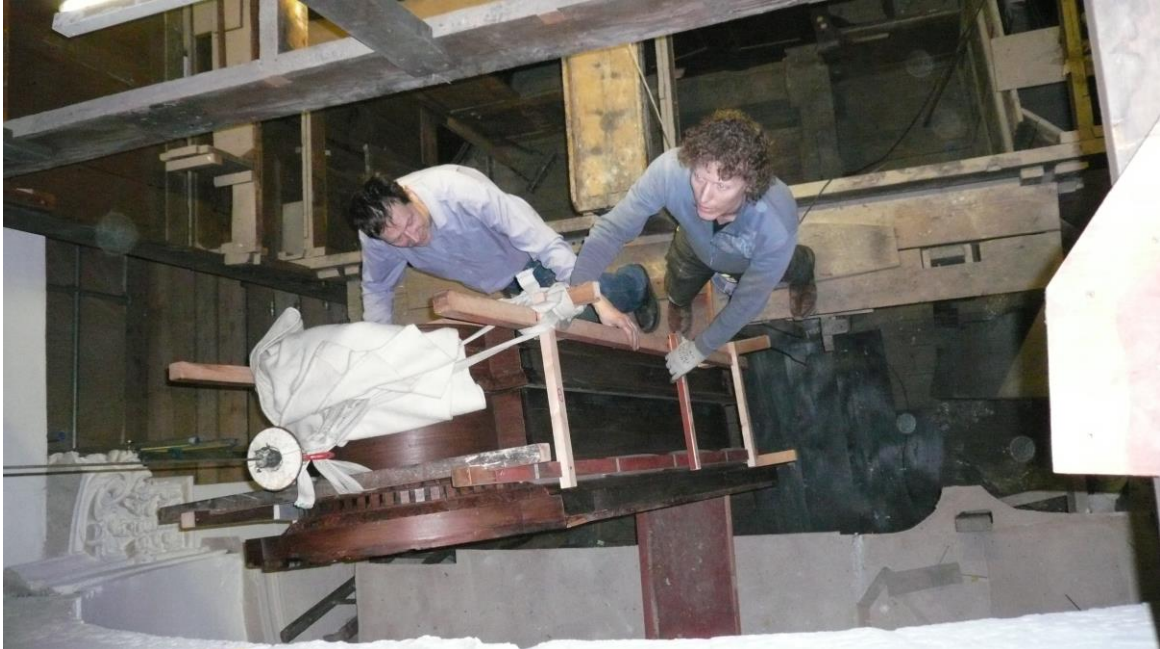
Exact fitting carrying cradles were made in order to be able to transport the bulky but extremely fragile structures

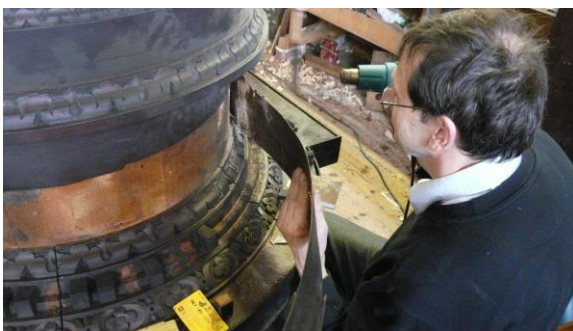
The immediately visible damage was in the condition of the veneers of the rounded parts of the frieze. They had been much patched and nailed back in places causing numerous splits. Only on one cornice this veneer could be saved. When the veneer was removed, the pine sub-structure which was coming adrift turned out to be severely affected by woodworm.

The removal of a frieze veneer

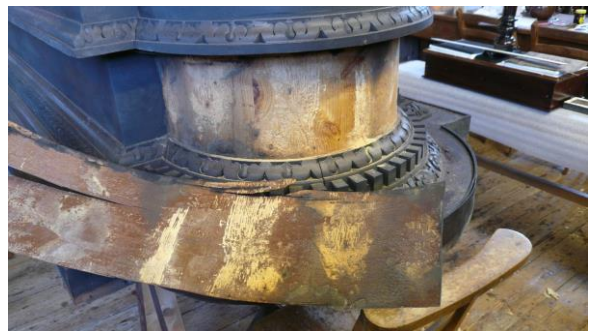
Woodworm damage to the pine sub-structure

After treating the possibly still active woodworm the barrels were repaired by re-glueing and filling splicing in thin strips of pine. The by woodworm eaten away surface was filled in with a mixture of wood dust and glue and shaped to become suitable for glueing back the veneer. A semi-circular clamping-aid was made to be able to glue the veneer with hot glue against the barrel shape, using many blocks and wedges.

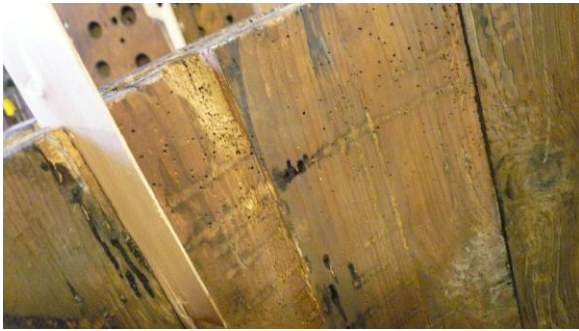
Repair of the barrel structure (woodworm damage evident)

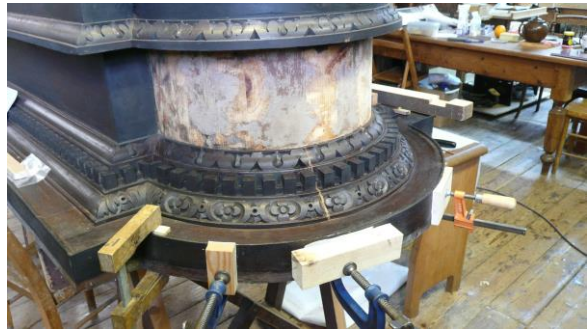
Woodworm damage filled in and surface prepared

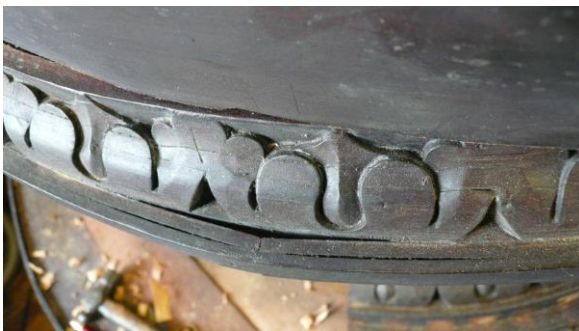
Laminated moulding coming apart because of shrinkage

The large top moulding consisting of segments and laminated strips of mahogany had come loose in many places. The top moulding of the cornice had been removed (or had fallen off) for the most part prior to dismantling. The segments were re-glued, in some cases also fastened with blind screws as there were already some present from very early days. Some very small open seams were left to allow for some future expansion room. Large gaps were filled with old matching wood. Some laminated pieces had to be cut and re-glued to make them fit against a shrunk background. The top most moulding was originally only fixed with very thin nails. To make this more secure and leave it removable for transport, this was now fitted with angled shaped blocks.

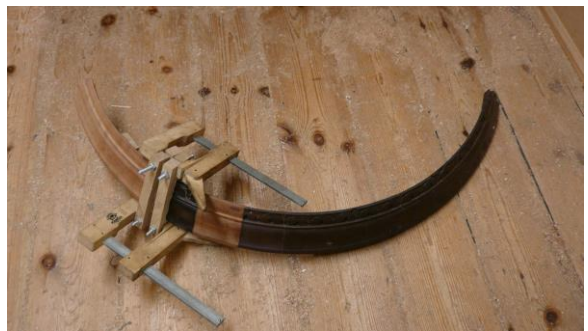
restoration of the top moulding

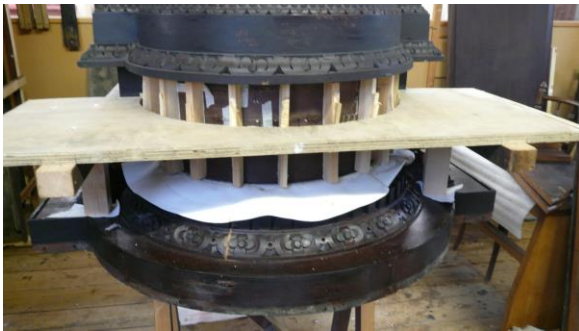
Clamping of the veneer

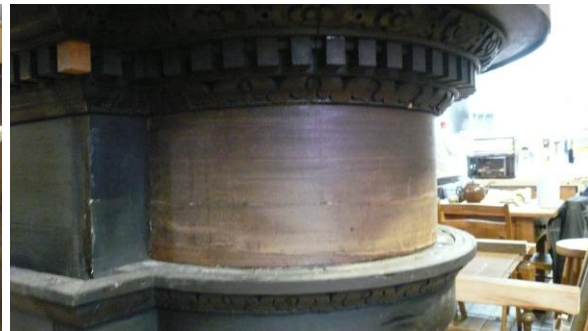
The veneer glued back in place

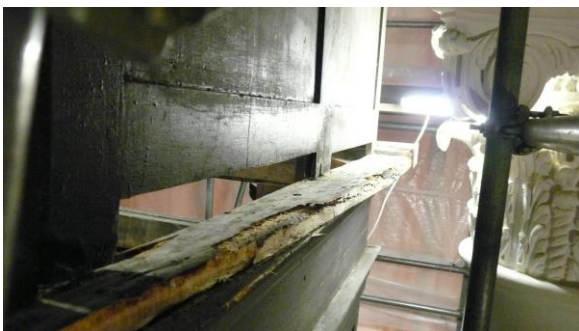
The Bass impost compromised by (historic) vermin attack

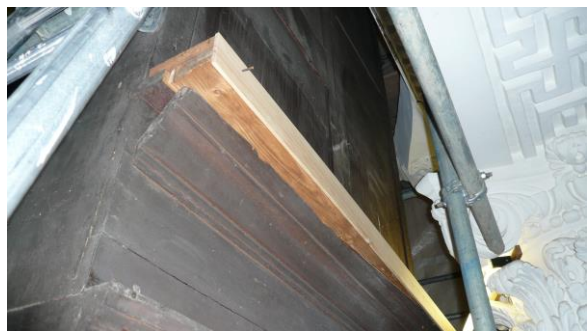
Compromised wood removed and replaced

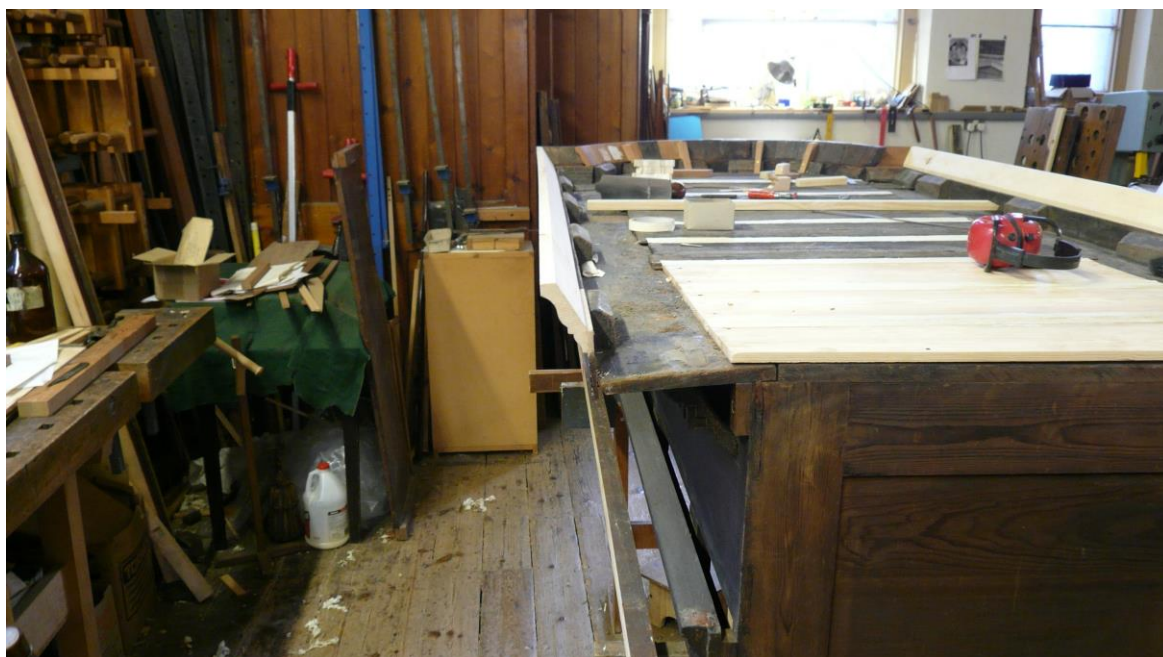
The cornice re-assembled in the workshop

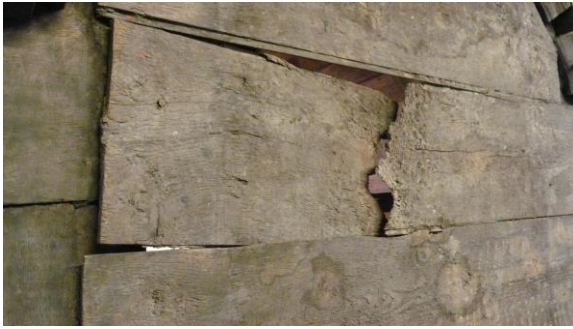
A broken roof plank

The roof of the organ is made of the roughest thin tongue and groove planks nailed down across the top edge. Some of the planks needed to be repaired and additional sections made. The joints were glued over with strips of linen to keep out dust in the future. The insides were treated with thinned linseed oil as an attempt to stabilise the rough surfaces with loose crumbly fibres. Finally the decision was taken that the finish should be removed at this stage as this would be an almost impossible task with the case re-assembled. This was done with de-natured alcohol.

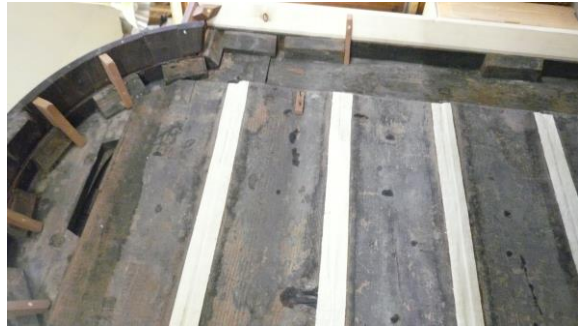
Angled shaped fixing blocks and the taped over joints

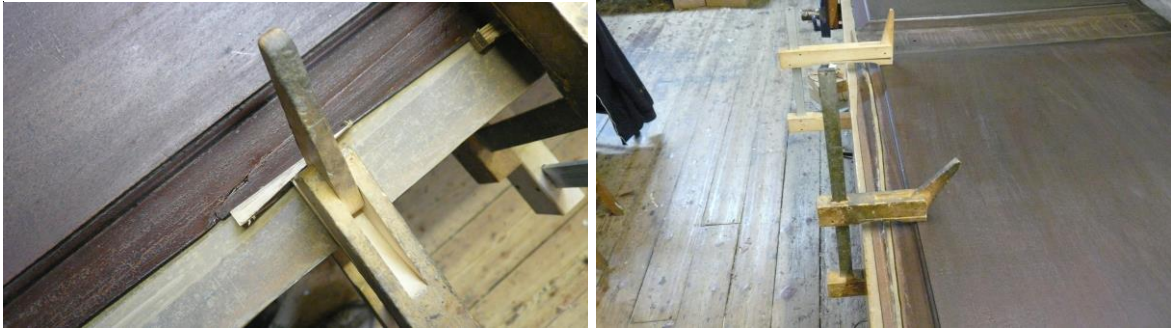
At some stage during the history of the organ these panels were removed by breaking open the groove in the framing from the back leaving a very untidy rebate. This was presumably done for easier access to be able to make significant changes to the original organ in the 19th century. The panels were then put back with a series of nails holding them against the rebate from the back.

The very thin edge of these panels (80 ½” x 31 ½” or 2045mm x 800mm) was badly splintered and broken.

Repair of splits in edge of panels

After glueing the surviving old fragments back in their original places, there remained a number of edges to be reconstructed with “new” wood.

New wood to reconstruct the edges was sourced from an old table of which the condition was beyond restoration. Also some old bed-ends found their way into being used to complete missing parts of the top cornices.

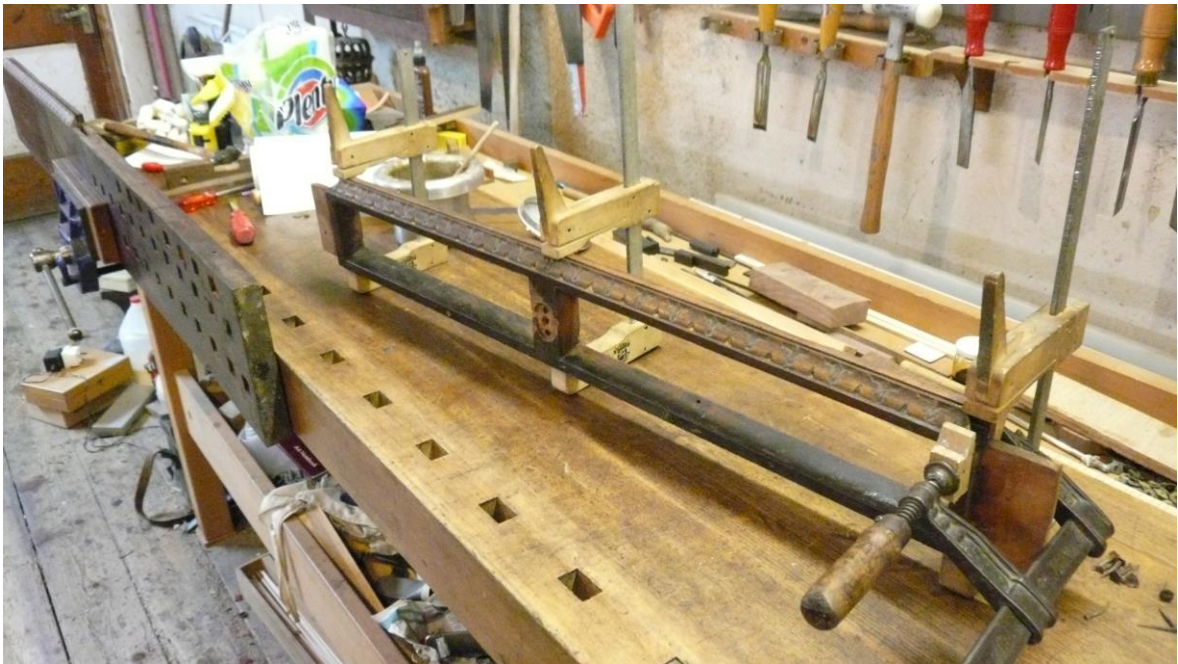
Preliminary repairs to the console area before stripping took place

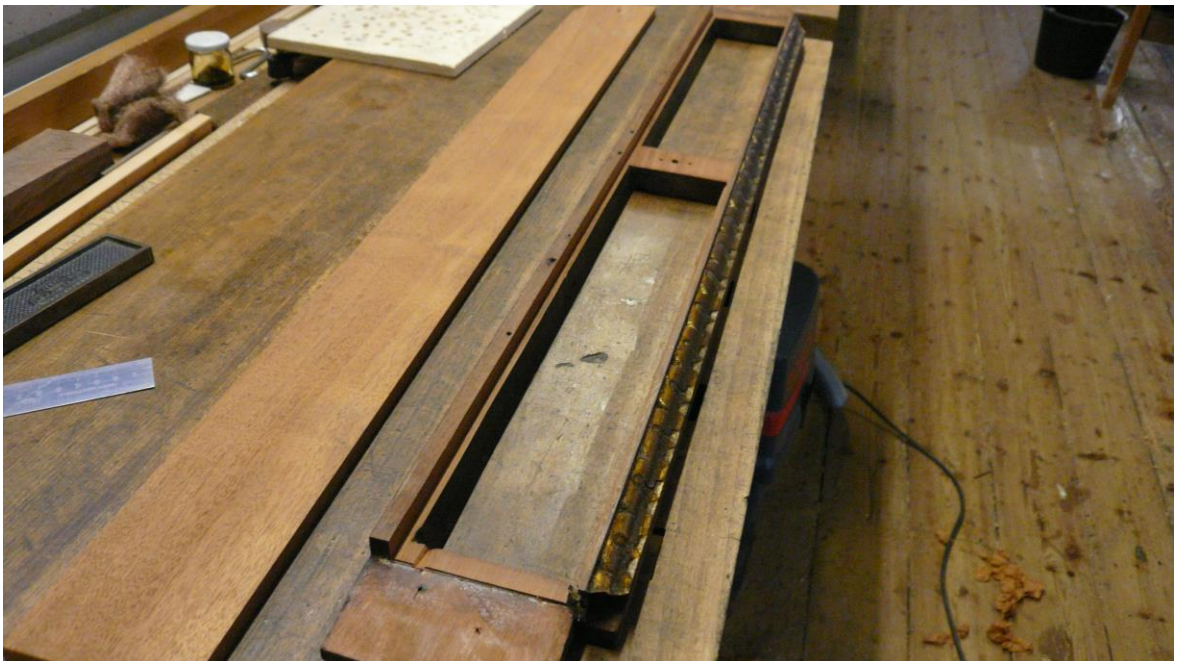
The rail above the music desk panel has had two letterbox shaped slots cut away possibly to allow for some form of early electric lighting or perhaps to increase the amount of sound reaching the organist's ears.

Rail with two letterbox-slots prepared for closing up with a thick veneer

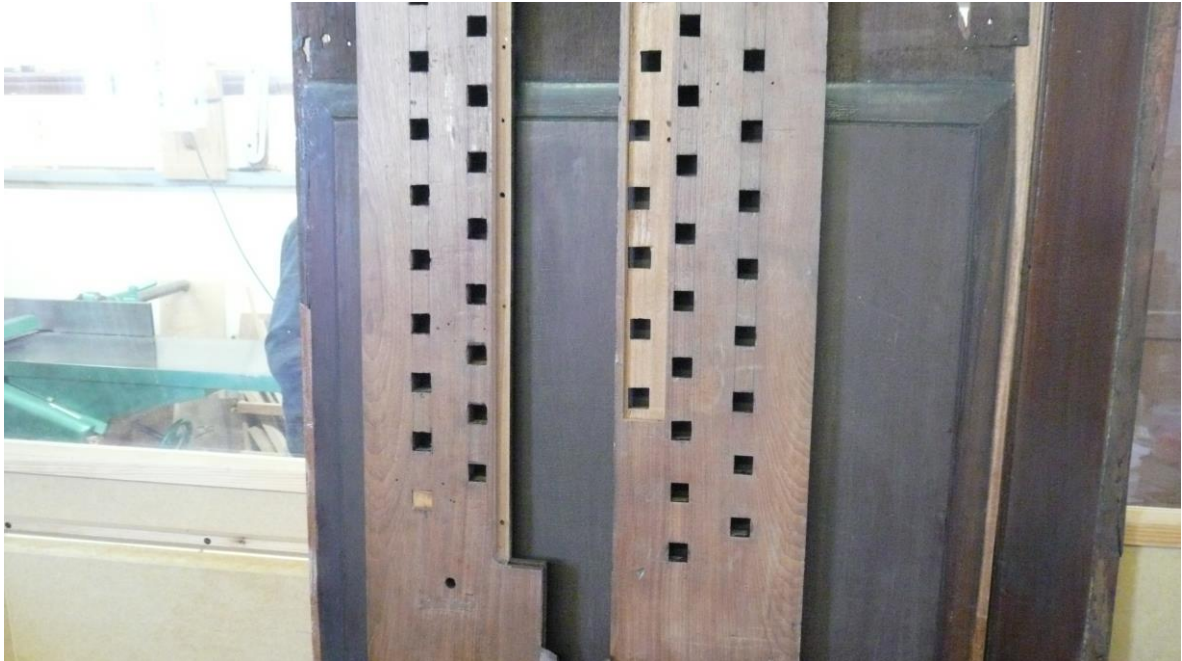
The original width of the stop jambs is 8" or 203mm. The space in between allows for a keyboard stack of 840mm wide. These jambs are connected by a top rail and a rail above the music desk panel. The Treble jamb had been cut narrower to allow for an increase in manual compass from top d" to top f".

The stop jambs standing up-side-down prepared for fitting in the veneers

The Treble stop jamb was restored to its original width by using a thick veneer grafted from the back of the right hand return. The return was restored to its original thickness with replacement Mahogany veneer.

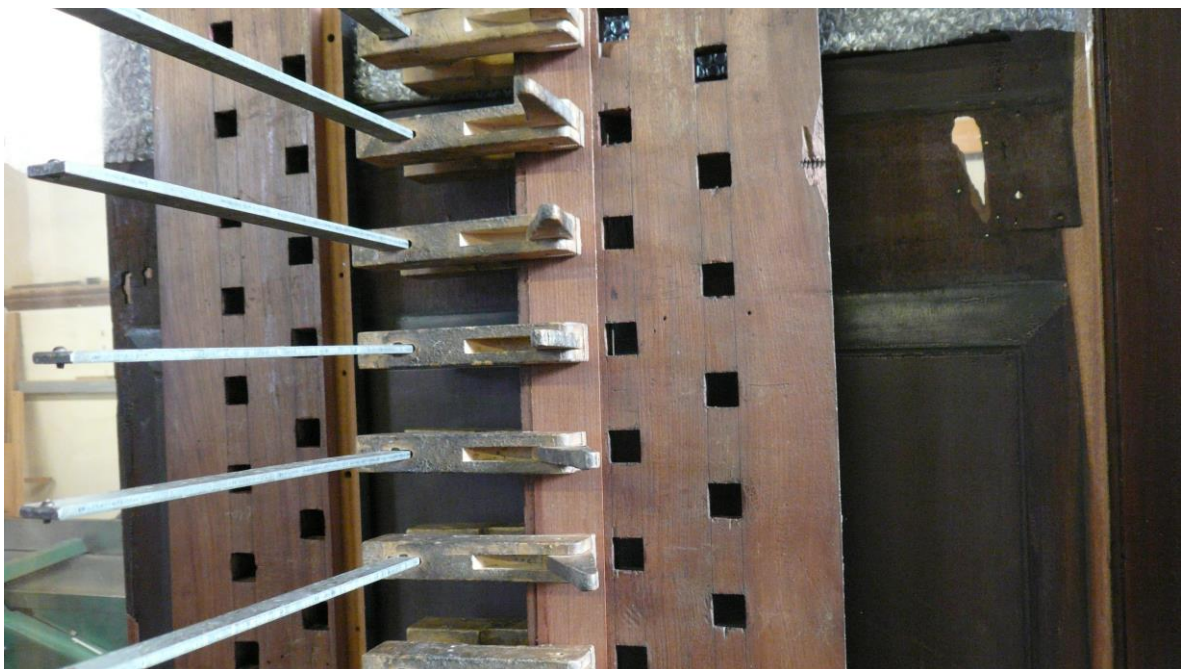
Veneer on Bass jamb being glued

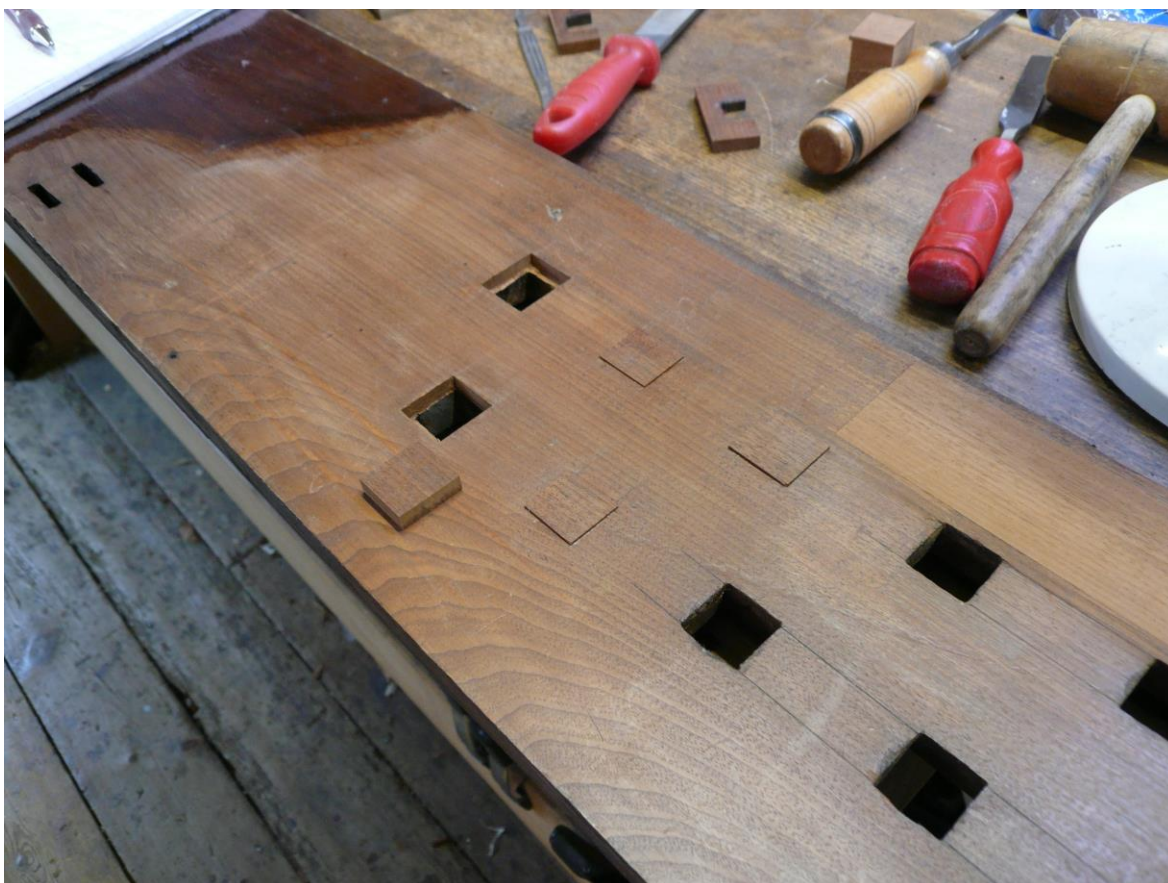
In the Bass jamb nine extra holes had been made next to the original holes. These were closed up by routing a slot, which was filled in with the grafted wood from the treble return. Above the original bass holes, five later added holes have been filled in and below the originals, one.

The Bass jamb being restored to the original number of holes

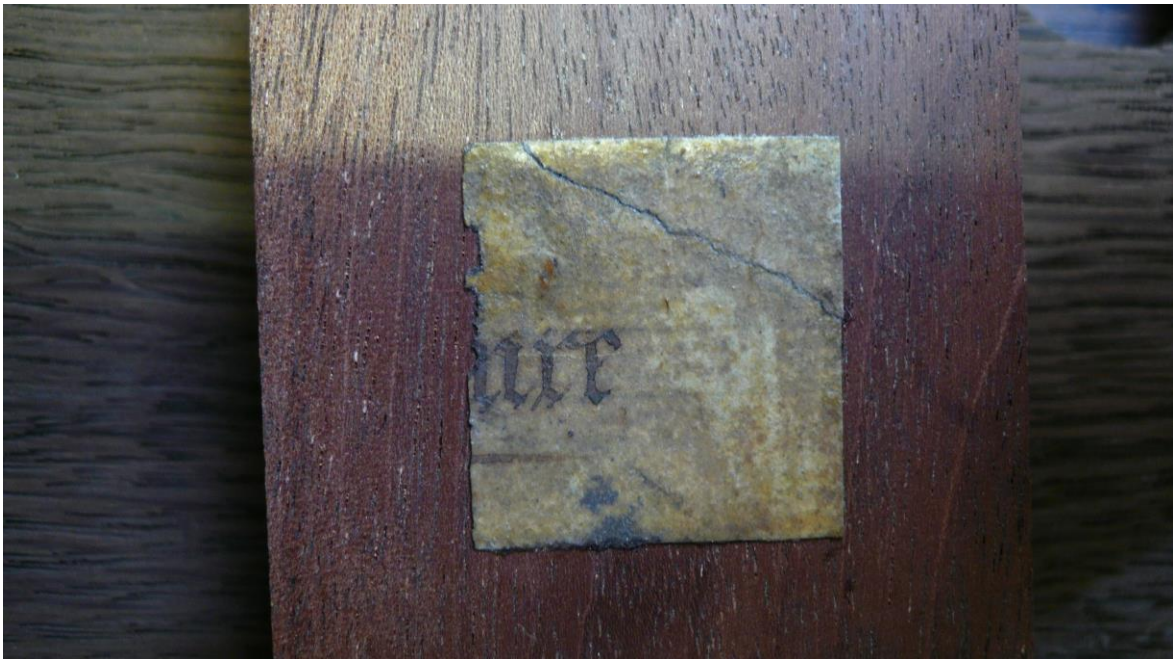
A fragment of a stop label was found under the floor by Red Mason during his survey in 1997. This fragment (24mm high) is made of laid-paper.

The surviving calligraphy shows the final three letters of a stop name "URE" in a gothic font.

The label fragment fixed to a piece of mahogany

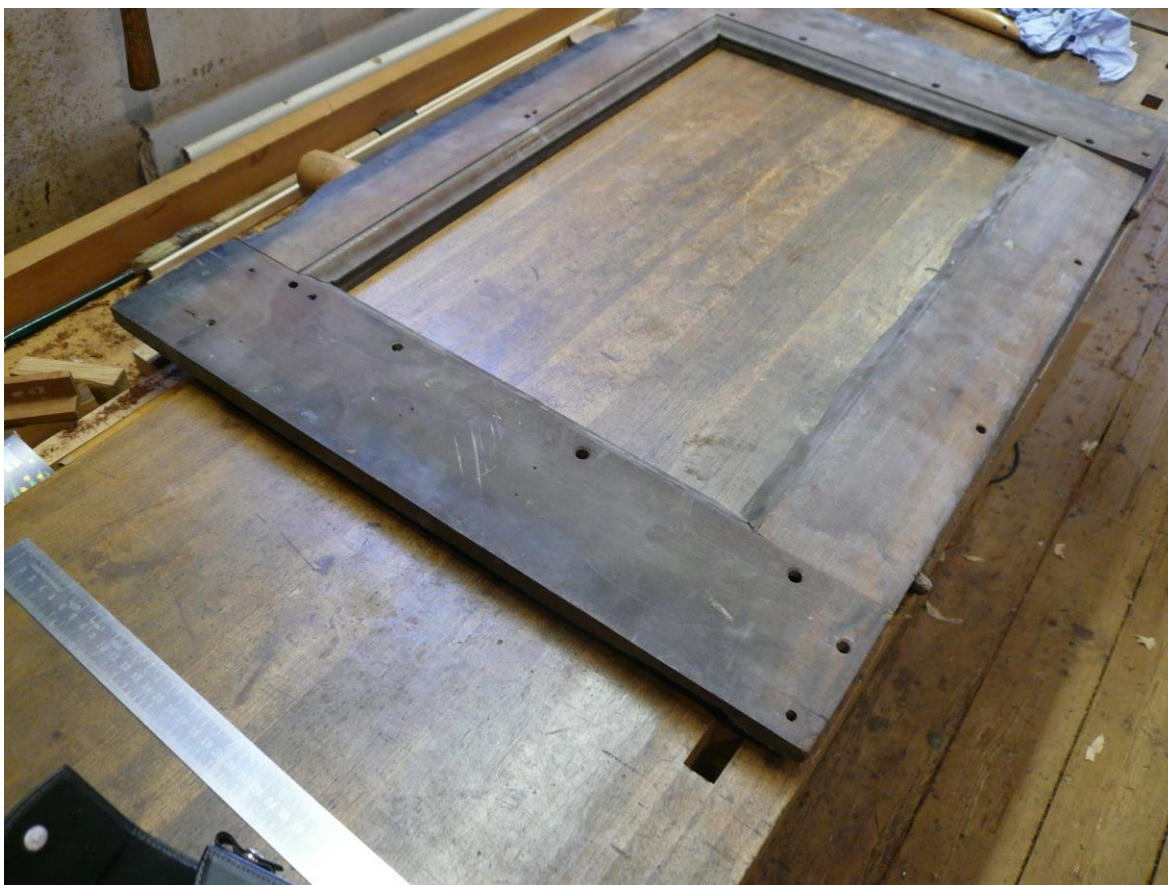
The parts of the original music desk frame were very cut about and sadly much drilled into. The uprights had been shortened by 17/19mm and the top rail narrowed by as much, and gouged out in two places. The edge of the ogee moulding was splintered away in several places. The panel filling had been cut out altogether (there was one fragment found, still stuck deep in the groove of the top rail).

The parts of the frame in a very sorry state

At face value, the original material looked like a write-off. The repair to fill in the holes and gouged out pieces was undertaken nevertheless. Once this process was on the way, things looked much more in favour of including the old material into a reconstruction of the music desk panel. The restored music desk panel was eventually used in up-side-down position. This way, the narrowed (originally) top rail (now bottom rail) was visually widened by sitting it on a cock-beaded rail on top of the keyboards. The visual effect is such, that one is no longer aware of the fact that this rail has been cut narrower.

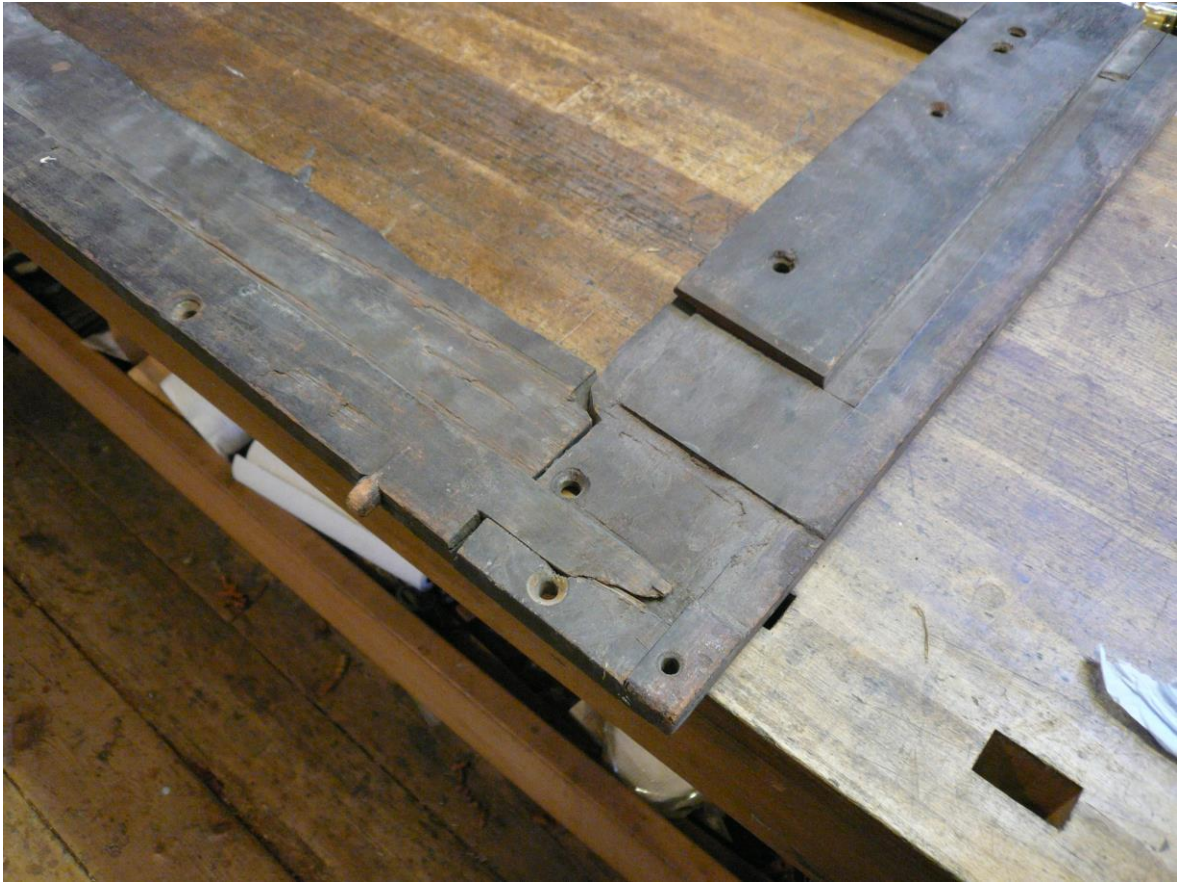
The back of the bottom rail cut away for the addition of an extra Swell coupler

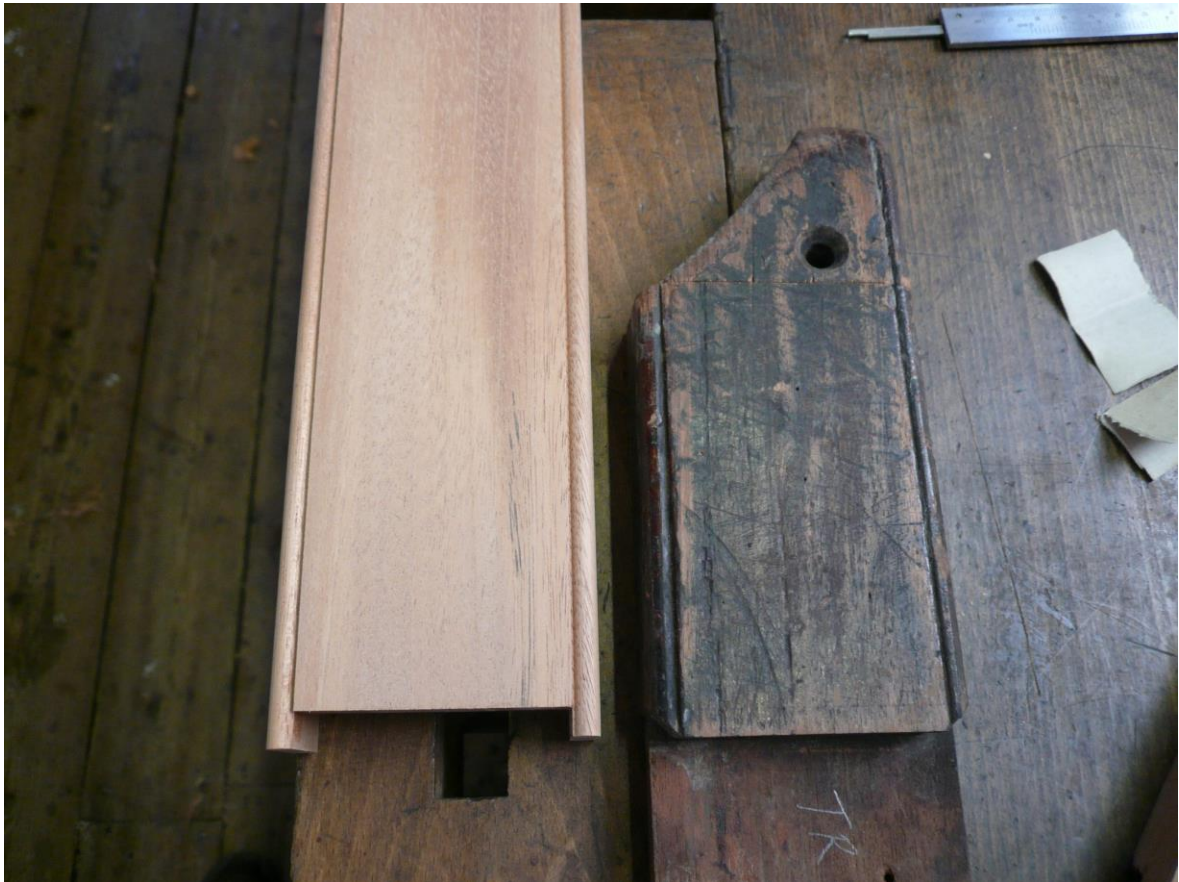
The case rail under the tall console doors was found much chopped about. Only short stumps from either ends of the rail were found with the tenons still intact.

New case rail next to old stump

The exact length needed for the restored rail was measured between the shoulders of the join with the uprights next to the console. The width, thickness and the dimensions of the cocked beads of the rail were measured from the existing stumps.

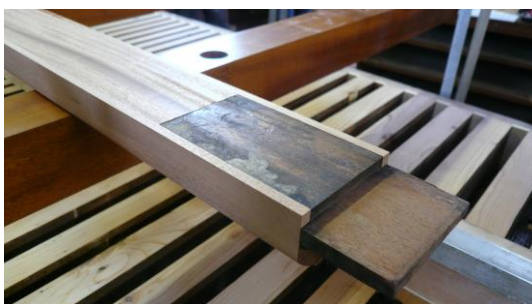
New mitres on the cocked beads to fit the old join

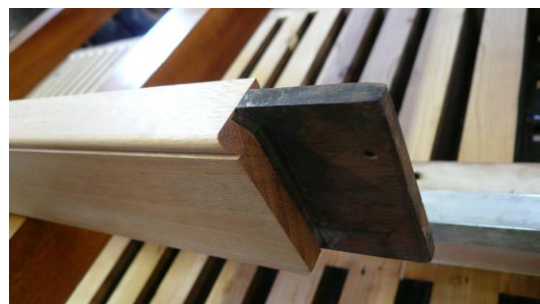
The old tenon inserted into the back of the new case rail

A new rail was made without tenons. The old stumps were cut to allow the original tenons to be inserted into a new rail from the back.

The rail was installed by first glueing the old tenons back into the old mortices, and then followed with glueing the new rail around the tenons flush with the front of the old uprights straight away afterwards.

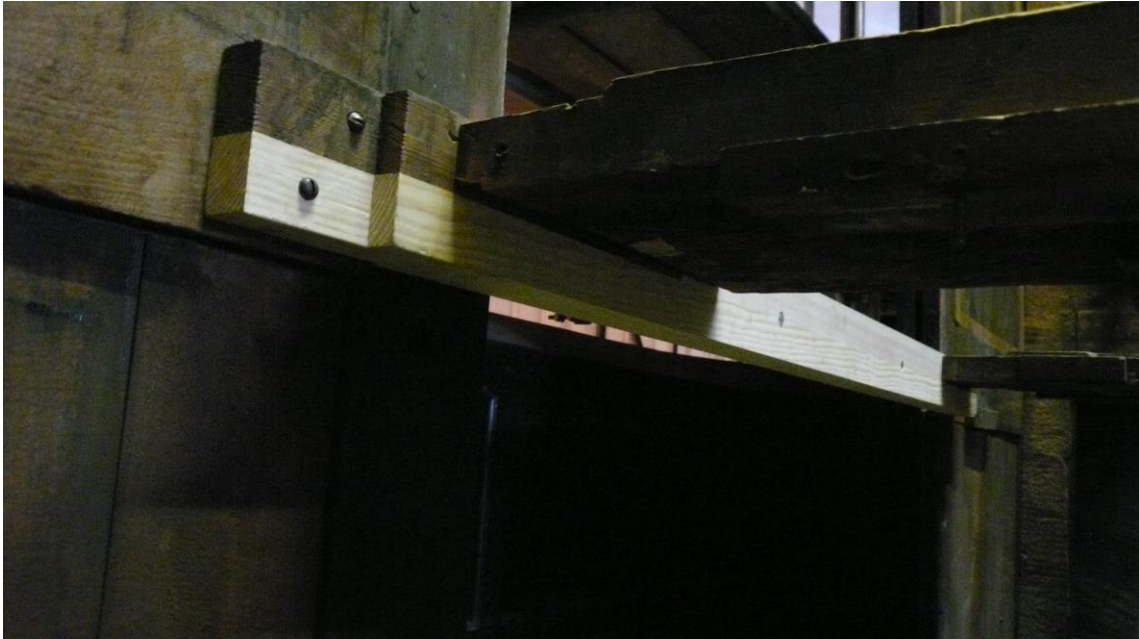
Also had the structural beam supporting the keyboards been sawn out, leaving the console structurally rather compromised. The long pivot boards supporting the stop action trundles, which were originally dovetailed into this, were now lacking sufficient support.

The structural beam supporting the keyboards and stop action re-instated (note the original roundhead screw at the top)

It was decided to reinstate both the supporting beam and the case rail. The latter was done mostly for aesthetic reasons.

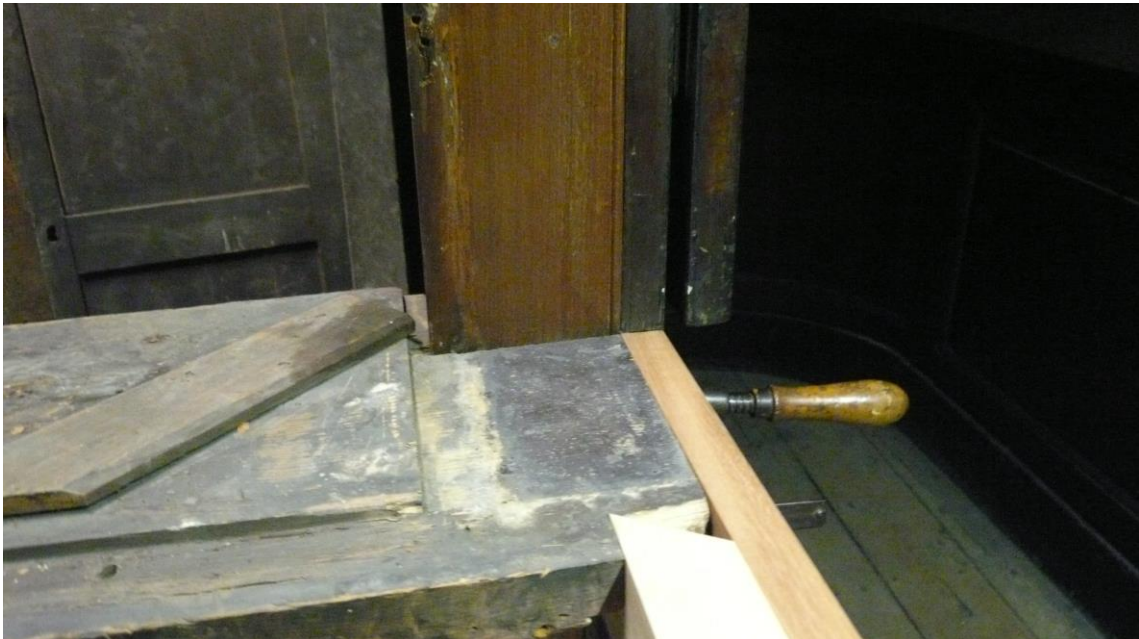
The case rail is glued back in place (note the dove-tail fitting of the stop action pivot boards)
