Case study  
The restoration  
of the  
1755 John Snetzler Organ  
at  
Clare College Cambridge

Keyboard & Action

**WILLIAM DRAKE Ltd**  
Organ Builder  
Chapel Street, Buckfastleigh, Devon TQ11 0AB

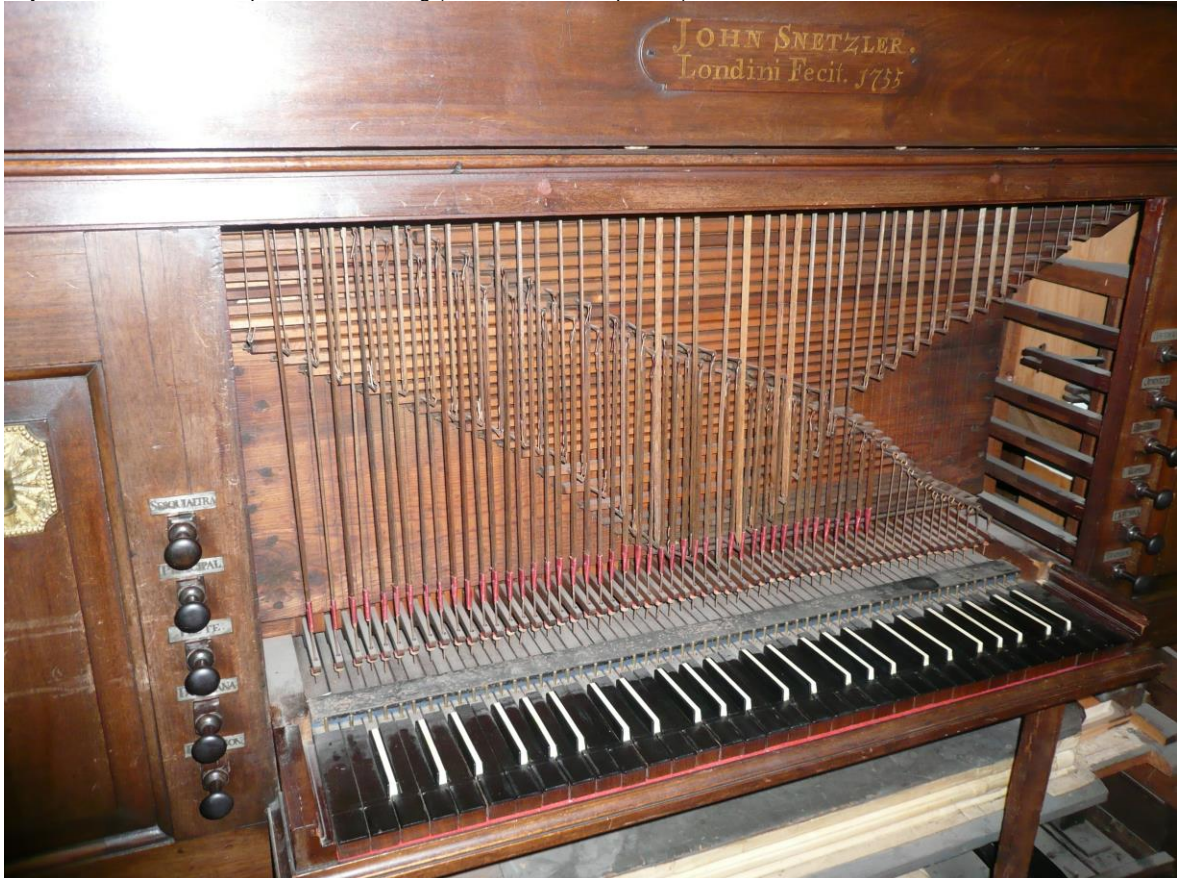
Keyboard and rollerboard prior to dismantling (note the iron thumper rail)

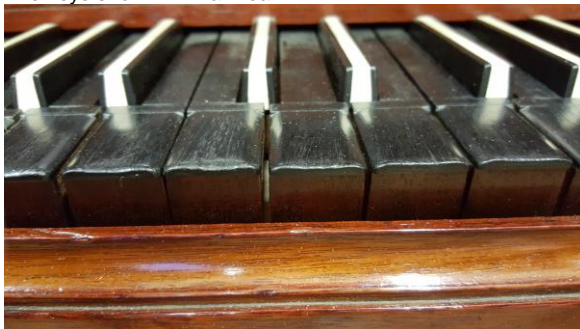
The keys show minimal wear

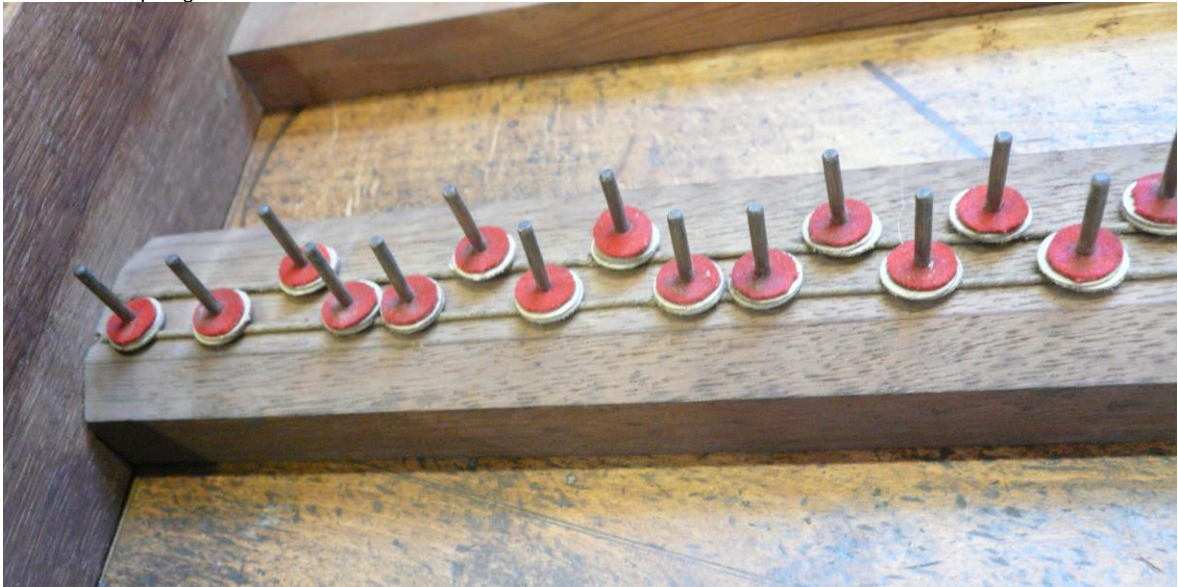
The guide, and balance pins are all of brass and didn't need much attention apart from cleaning. Latterly the keyboard had acquired a large amount of cardboard and red cloth washers under the balance point of the keys. Also a thick cushion of felt had been inserted under the front. On closer inspection, under all the washers, two gut cables were found, like the ones which are employed for clock weights.

The Cloth and cardboard washers which had been inserted were found to compensate for a warped balance-pin rail (3mm down in the middle).

Washers on top of gut cable

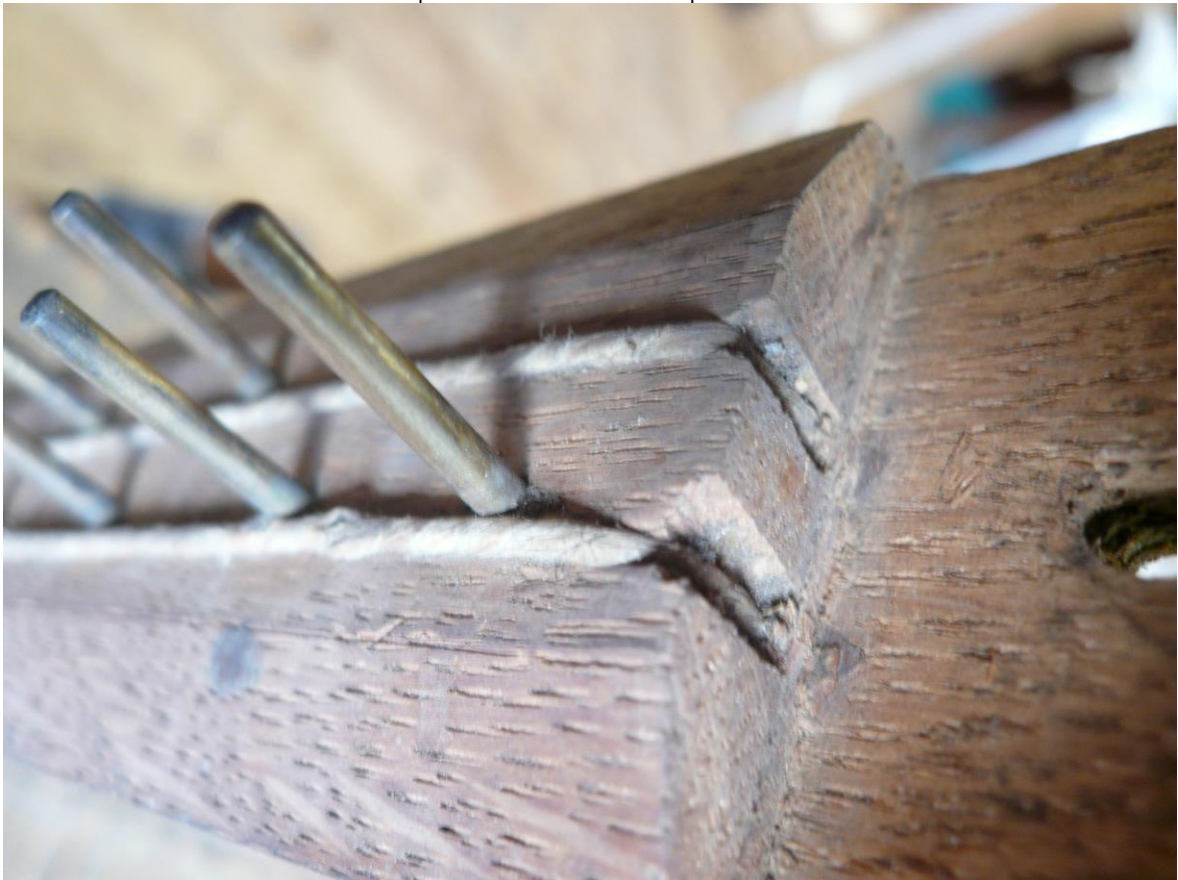
Gut cables anchored in front of the balance-pins with small brads under quite some tension

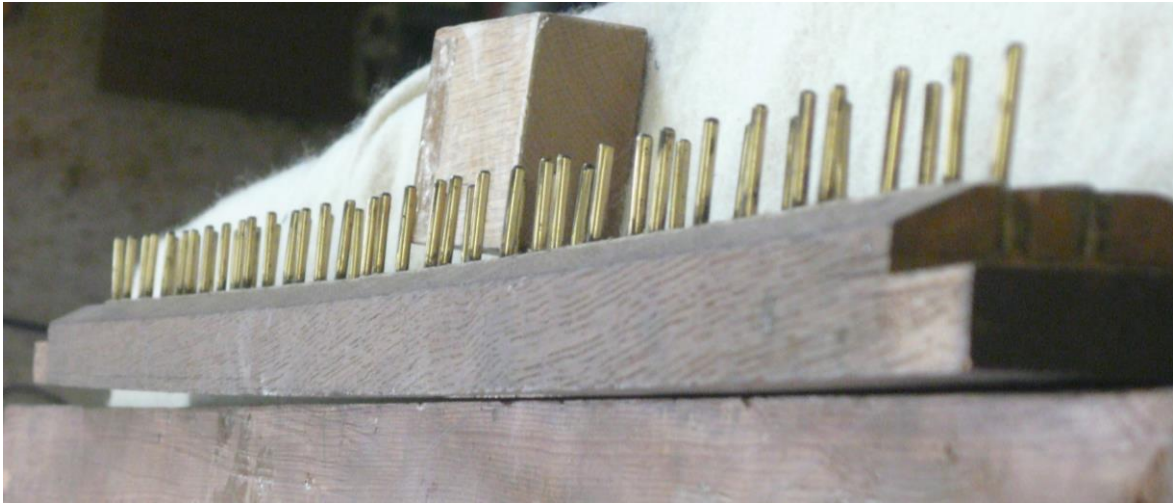
The balance rail shows a severe bend

The bend in the balance rail had to be corrected without disturbing the pins and original gut cables. This was done by making substantial grooves in strategic places along the bottom of the rail, into which new wooden slats were glued while the rail was kept straight.

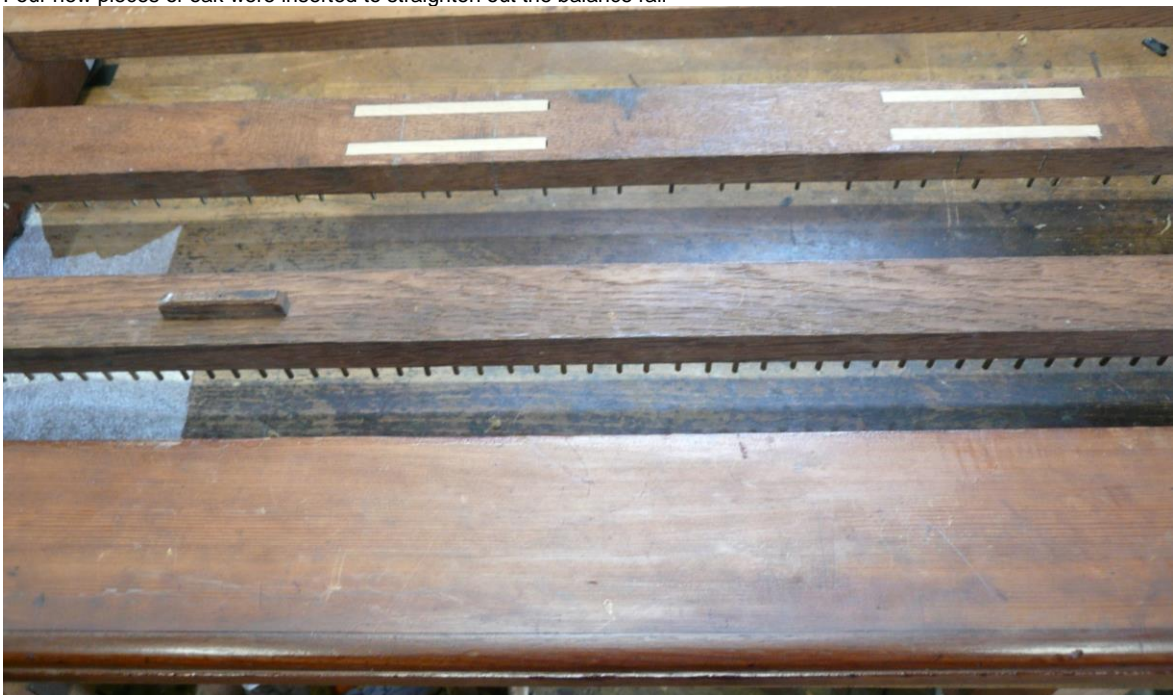
Four new pieces of oak were inserted to straighten out the balance rail

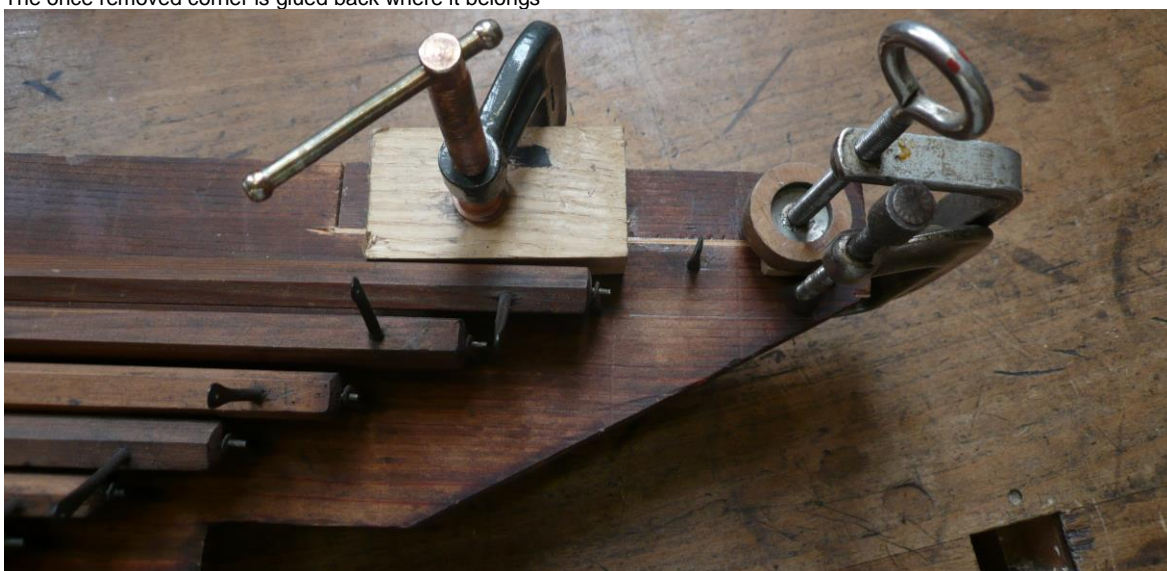
The rollerboard was in a good condition and only required cleaning and some repair. The treble corner had been sawn out to make space for the altered wind trunk. The piece of wood had not been thrown away and was found in the bottom of the organ under the bellows. This piece was glued back to restore its original form.

The once removed corner is glued back where it belongs

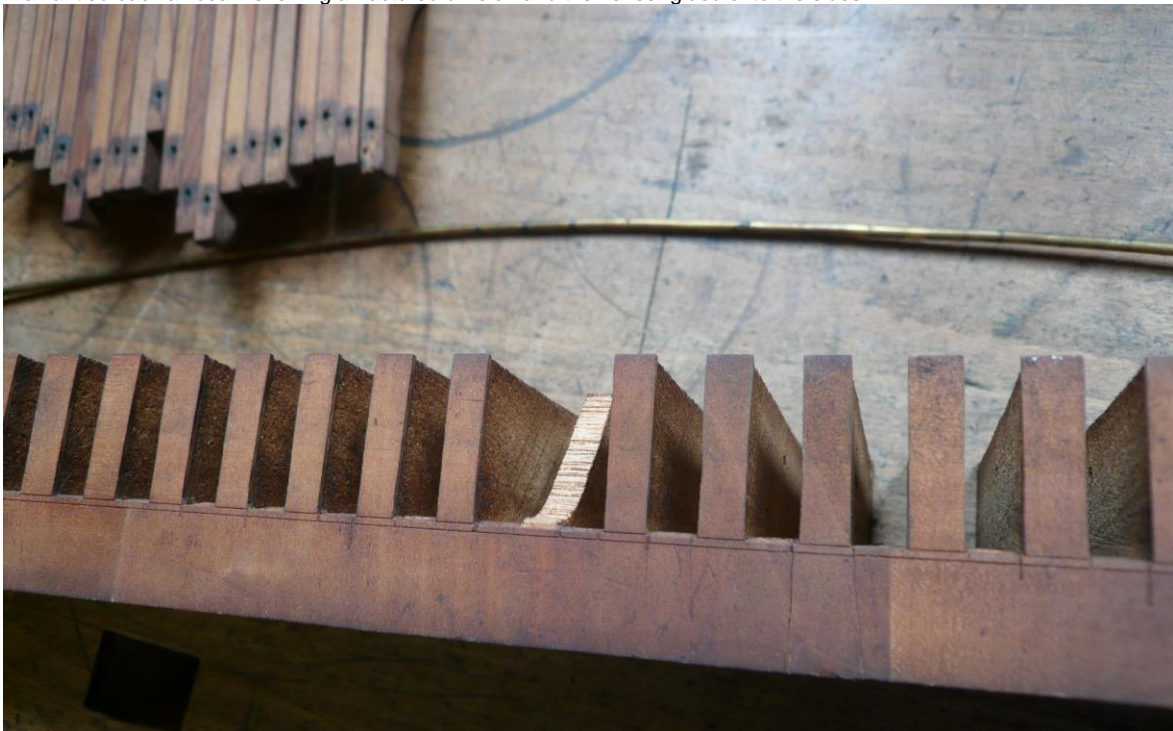
Dismantled backfall beam showing a fractured division and the veneer glued onto the sides

The backfall beam was in a reasonable condition and only needed minor repair and cleaning. The pivot was removed, cleaned, straightened and put back in.

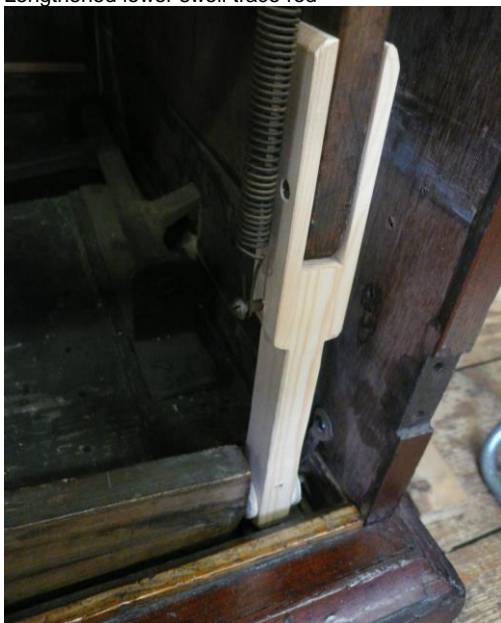
Lengthened lower swell trace rod

The swell front was made to run smoothly, and an added weight on the top lever was maintained as it reduces the force needed to open the box (fragile mechanism). The lower lever was latterly fixed to the top of the bellows valve board. This lever was again fixed to the top after having glued on a wedge shape section to compensate for the restored angled position of this valve board. The trace rod had to be lengthened because of this slightly higher position. We chose to do this in a reversible way by adding a new section to the old. The upward trace rod (not original) was shortened.

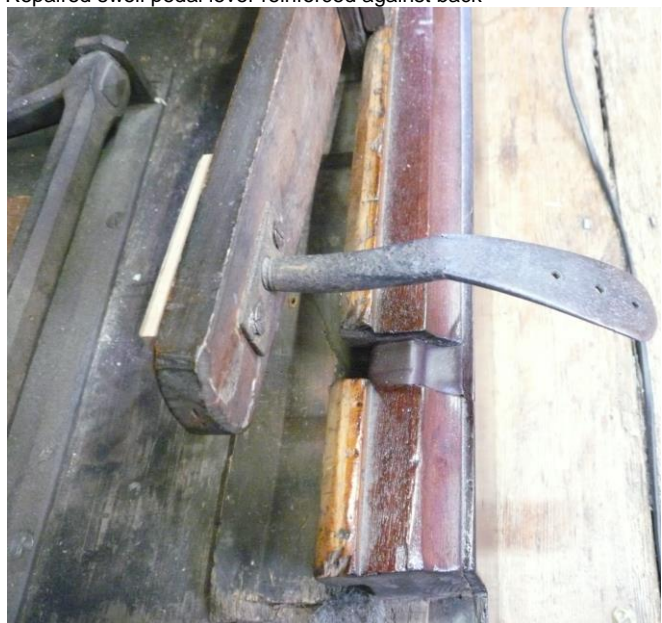
Repaired swell pedal lever reinforced against back
