Case study
on the restoration
of the
1735 Richard Bridge Organ
at
Christ Church Spitalfields

The Organ Case

WILLIAM DRAKE Ltd
Organ Builder
Chapel Street, Buckfastleigh, Devon TQ11 0AB

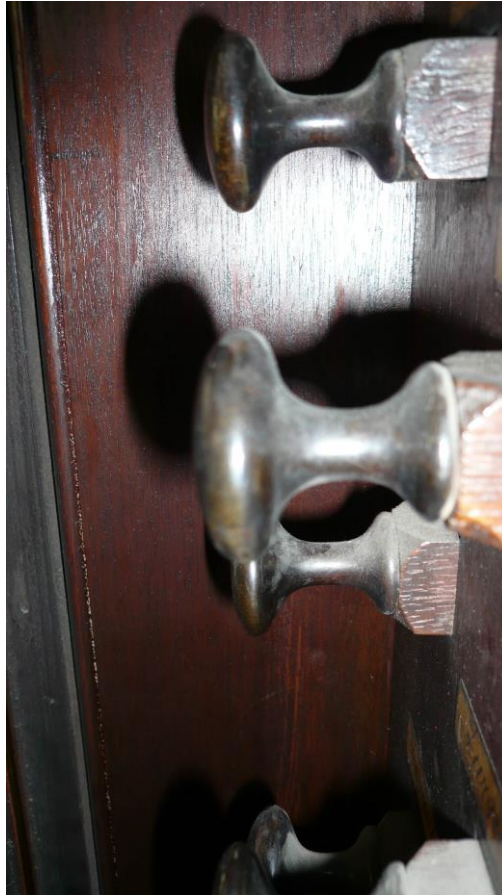
The Shoreditch stop knobs in Ebony

The details for the keyboards and the stop knobs have been copied from the 1756 Richard Bridge organ in Shoreditch. (see action)

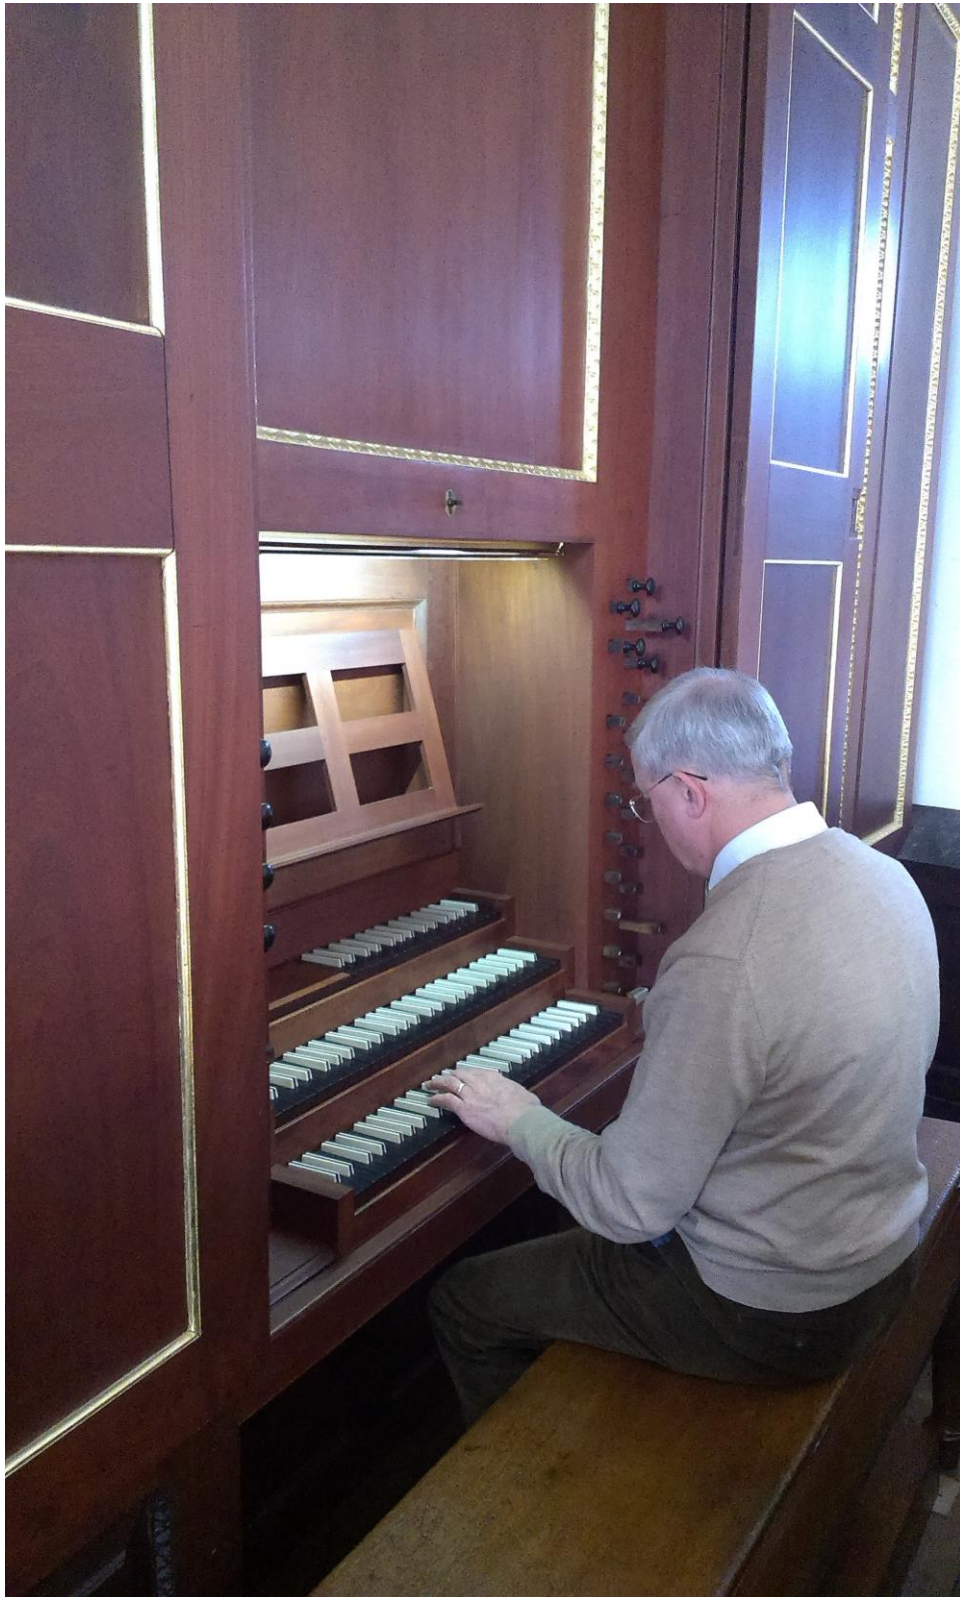
David Frostick at the almost complete reconstructed console during the finishing of the reed stops

The key levers in Shoreditch are made in pine. In Spitalfields many of the action components (even the trackers) are executed in oak. We therefore argued that there was a strong case here, for making the key levers in oak instead of pine. The naturals are covered in ebony and the sharps are in Skunk-tail fashion, a sandwich of two pieces of bone (ivory in Shoreditch) with ebony in the middle.

The keyboard cheeks of the Shoreditch Bridge organ are cleverly made up of a pine core clad with thick mahogany veneers which are mitred blind on the corners. The keyboard cheeks for Spitalfields were carried out in the same manner but with an oak core instead.
