Case study  
The restoration  
of the  
1755 John Snetzler Organ  
at  
Clare College Cambridge

Keyboard & Action

**WILLIAM DRAKE Ltd**  
Organ Builder  
Chapel Street, Buckfastleigh, Devon TQ11 0AB

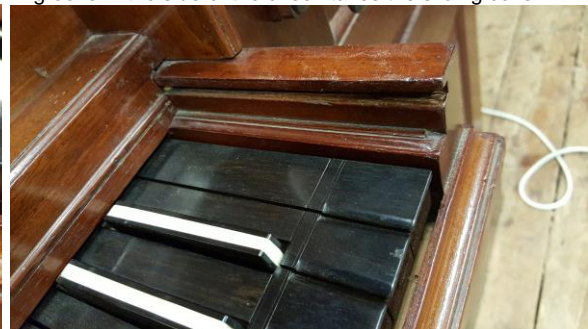
A groove in the side of the cheek takes the sliding cover

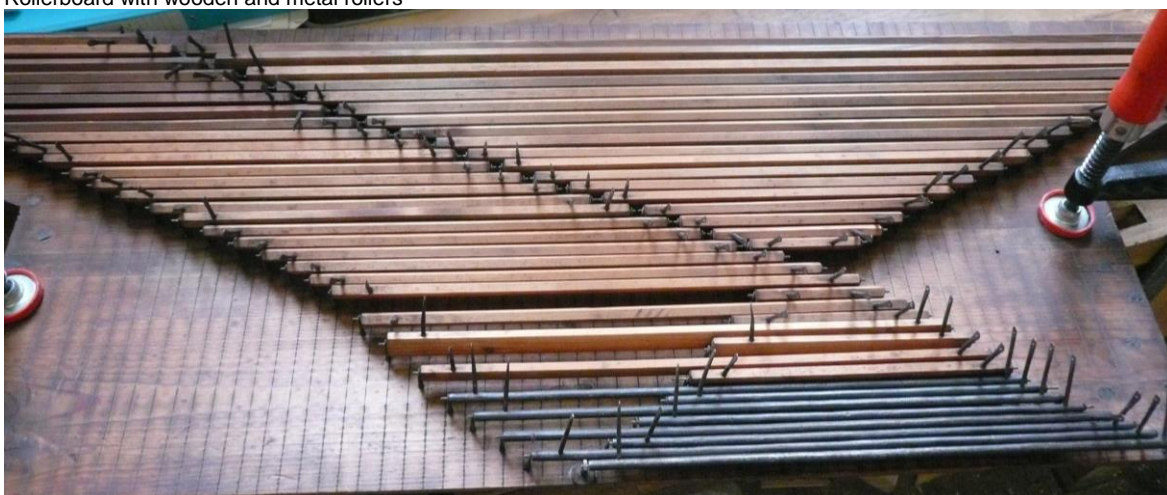
Rollerboard with wooden and metal rollers

The back-board and the majority of rollers are of fine grained pine, roller studs and arms of steel and pivots of brass. The lower end of the rollerboard is pushed forward by the backfall beam, putting it at a slight forward angle. The rollerboard is fixed to the bottom of the soundboard with two small iron brackets. Most of the rollers are of finest grade pine and planted at a fine spacing. There are 8 steel rollers because of space considerations.

The rollerboard was in a good condition and only required cleaning and some repair. The treble corner had been sawn out to make space for the altered wind trunk. The piece of wood had not been thrown away and was found in the bottom of the organ under the bellows. This piece was glued back to restore its original form.

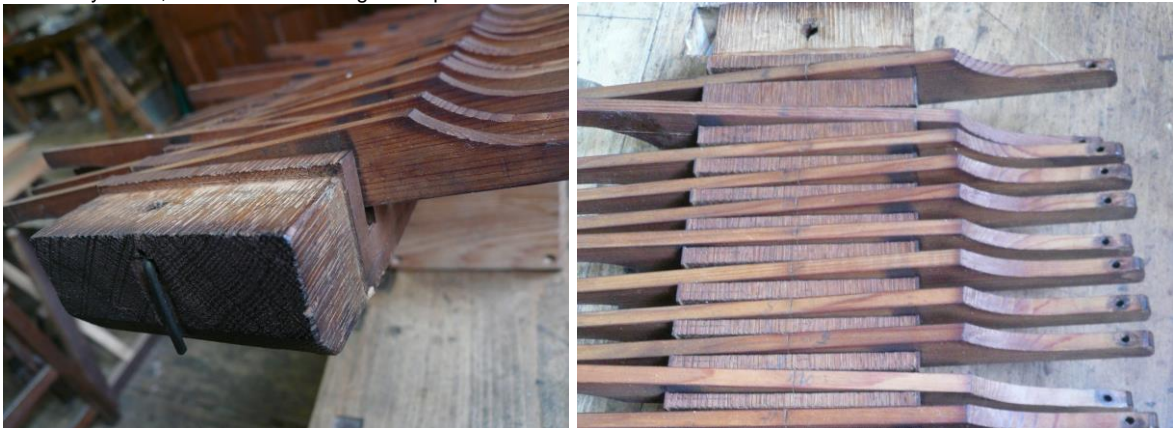
Beautifully made, oak beam with fine grained pine levers

Both sides of the beam are covered with a thick vertical grain (fruit wood?) veneer which is slightly proud of the surface of the slots. One presumes this was done to minimise friction.

The backfall beam was in a reasonable condition and only needed minor repair and cleaning. The pivot was removed, cleaned, straightened and put back in.
